**Flood Control Project Maintenance
Levee Inspections**
LMA District Cover Sheet
Spring 2018 Levee Inspection Results

Reclamation District No. 0784 Plumas Lake

Spring 2018 Levee Inspection Results

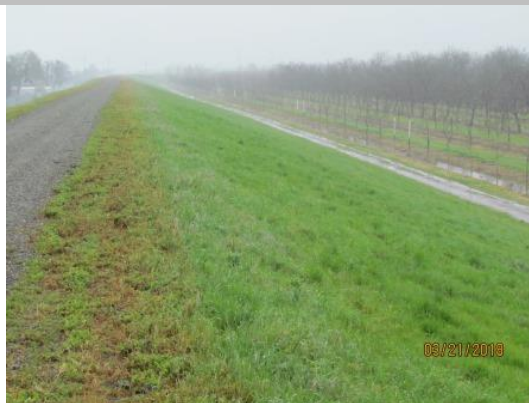
Photo 1 of 1 : SP_2018_RD0784_531_3_20180409_00004.jpg

LM Start	0.02	Rating **	A	Issue No.	3
LM End	2.53	Issue Type +	Ma	Location *	WS
Category	Earthen Levee		GPS Latitude/Longitude		
			Start	End	
Item	Vegetation		39.125496 °	39.090499 °	
			-121.588649 °	-121.584667 °	
DWR ID	DWR_RD0784_02A_s_2018_3				
Comment Code					
V1 : Control annual grass and weeds on the levee slopes and easements.					
Inspector Comment					
Annual vegetation is well maintained, Spring 2018.

View looking downstream waterside of the well maintained annual vegetation, Spring 2018.

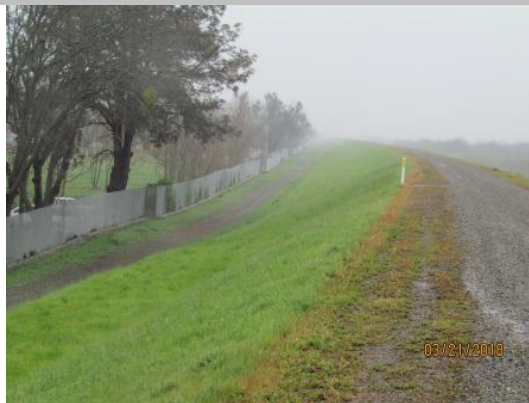
Photo 1 of 1 : SP_2018_RD0784_531_2_20180409_00005.jpg

LM Start	0.02	Rating **	A	Issue No.	2
LM End	2.53	Issue Type +	Ma	Location *	LS
Category	Earthen Levee			GPS Latitude/Longitude	
				Start	End
Item	Vegetation			39.125495 °	39.090499 °
				-121.588649 °	-121.584667 °
DWR ID	DWR_RD0784_02A_s_2018_2				
Comment Code					
V1 : Control annual grass and weeds on the levee slopes and easements.					
Inspector Comment					
Annual vegetation is well maintained, Spring 2018.

View looking downstream landside of the well maintained annual vegetation, Spring 2018.

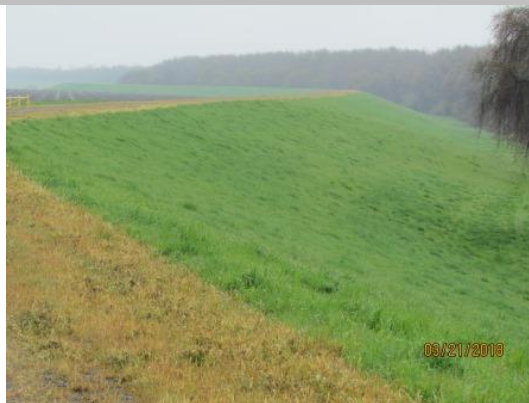
Photo 1 of 1 : SP_2018_RD0784_532_3_20180409_00008.jpg

LM Start	8.97	Rating **	A	Issue No.	3
LM End	12.85	Issue Type +	Ma	Location *	WS
Category	Earthen Levee			GPS Latitude/Longitude	
				Start	End
Item	Vegetation			39.009879 °	38.954721 °
				-121.579154 °	-121.574747 °
DWR ID	DWR_RD0784_02B_s_2018_3				
Comment Code					
V1 : Control annual grass and weeds on the levee slopes and easements.					
Inspector Comment					
Annual vegetation is well maintained, Spring 2018.

View looking downstream waterside of the well maintained annual vegetation, Spring 2018.

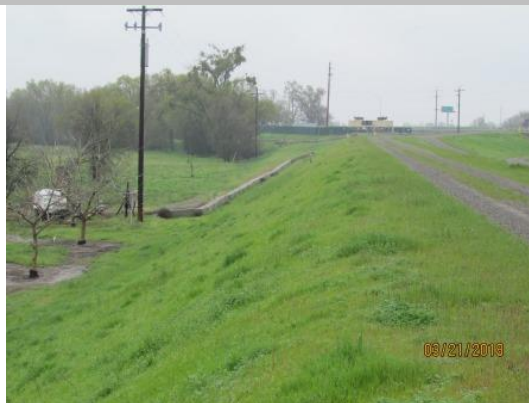
Photo 1 of 1 : SP_2018_RD0784_533_1_20180409_00001.jpg

LM Start	2.44	Rating **	A	Issue No.	1
LM End	3.20	Issue Type +	Ma	Location *	LS
Category	Earthen Levee			GPS Latitude/Longitude	
				Start	End
Item	Vegetation			38.970776 °	38.974685 °
				-121.547447 °	-121.535307 °
DWR ID	DWR_RD0784_03A_s_2018_1				
Comment Code					
V1 : Control annual grass and weeds on the levee slopes and easements.					
Inspector Comment					
Annual vegetation is well maintained, Spring 2018.

View looking upstream landside of the well maintained annual vegetation, Spring 2018.

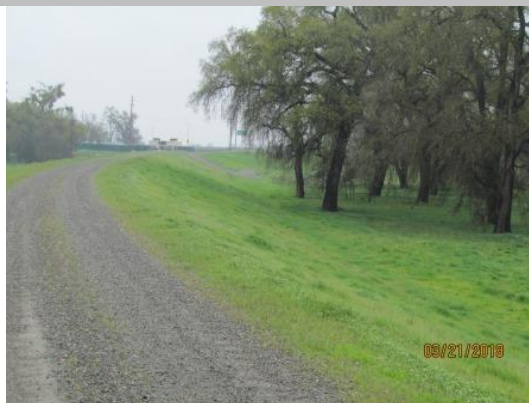
Photo 1 of 1 : SP_2018_RD0784_533_2_20180409_00002.jpg

LM Start	2.44	Rating **	A	Issue No.	2
LM End	3.20	Issue Type +	Ma	Location *	WS
Category	Earthen Levee			GPS Latitude/Longitude	
				Start	End
Item	Vegetation			38.970776 °	38.974685 °
				-121.547447 °	-121.535306 °
DWR ID	DWR_RD0784_03A_s_2018_2				
Comment Code					
V1 : Control annual grass and weeds on the levee slopes and easements.					
Inspector Comment					
Annual vegetation is well maintained, 2018.

View looking upstream waterside of the well maintained annual vegetation, Spring 2018.

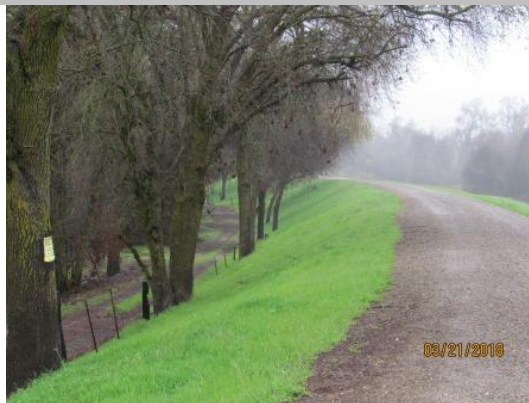
Photo 1 of 1 : SP_2018_RD0784_534_3_20180409_00005.jpg

LM Start	3.22	Rating **	A	Issue No.	3
LM End	4.68	Issue Type +	Ma	Location *	LS
Category	Earthen Levee			GPS Latitude/Longitude	
				Start	End
Item	Vegetation			38.974382 °	38.985412 °
				-121.532269 °	-121.510796 °
DWR ID	DWR_RD0784_03B_s_2018_3				
Comment Code					
V1 : Control annual grass and weeds on the levee slopes and easements.					
Inspector Comment					
Annual vegetation is well maintained, Spring 2018.

View looking upstream landside of the well maintained annual vegetation, Spring 2018.

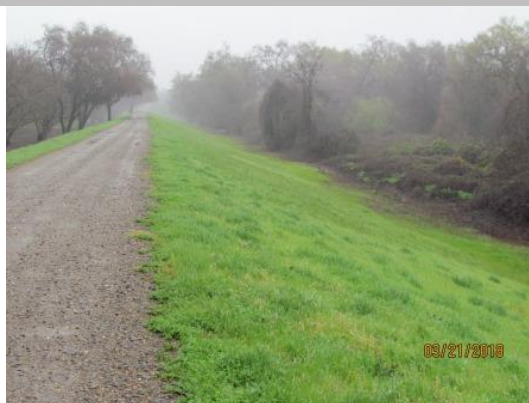
Photo 1 of 1 : SP_2018_RD0784_534_4_20180409_00006.jpg

LM Start	3.23	Rating **	A	Issue No.	4
LM End	4.68	Issue Type +	Ma	Location *	WS
Category	Earthen Levee			GPS Latitude/Longitude	
				Start	End
Item	Vegetation			38.974358 °	38.985412 °
				-121.532189 °	-121.510795 °
DWR ID	DWR_RD0784_03B_s_2018_4				
Comment Code					
V1 : Control annual grass and weeds on the levee slopes and easements.					
Inspector Comment					
Annual vegetation is well maintained, Spring 2018.

View looking upstream waterside of the well maintained annual vegetation, Spring 2018.

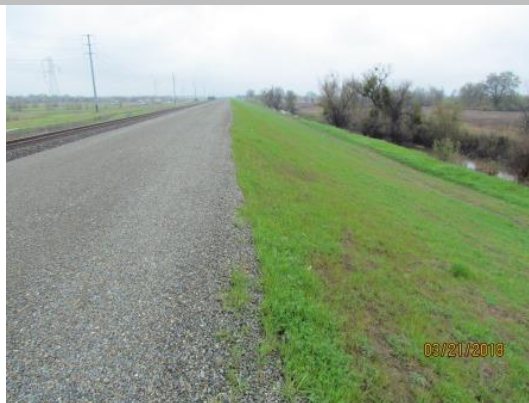
Photo 1 of 1 : SP_2018_RD0784_181_3_20180409_00004.jpg

LM Start	0.00	Rating **	A	Issue No.	3
LM End	6.32	Issue Type +	Ma	Location *	WS
Category	Earthen Levee			GPS Latitude/Longitude	
				Start	End
Item	Vegetation			38.974776 °	39.059298 °
				-121.535089 °	-121.551067 °
DWR ID	DWR_RD0784_04_s_2018_3				
Comment Code					
V1 : Control annual grass and weeds on the levee slopes and easements.					
Inspector Comment					
Annual vegetation is well maintained, Spring 2018.

View looking upstream waterside of the well maintained annual vegetation, Spring 2018.

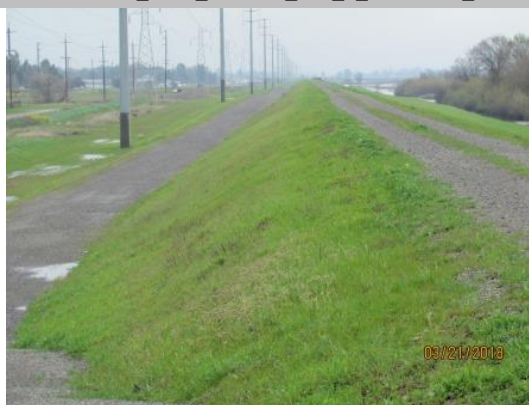
Photo 1 of 1 : SP_2018_RD0784_181_2_20180409_00006.jpg

LM Start	0.00	Rating **	A	Issue No.	2
LM End	6.32	Issue Type +	Ma	Location *	LS
Category	Earthen Levee			GPS Latitude/Longitude	
				Start	End
Item	Vegetation			38.974776 °	39.059297 °
				-121.535089 °	-121.551067 °
DWR ID	DWR_RD0784_04_s_2018_2				
Comment Code					
V1 : Control annual grass and weeds on the levee slopes and easements.					
Inspector Comment					
Annual vegetation is well maintained, Spring 2018.

View looking upstream landside of the well maintained annual vegetation, Spring 2018.

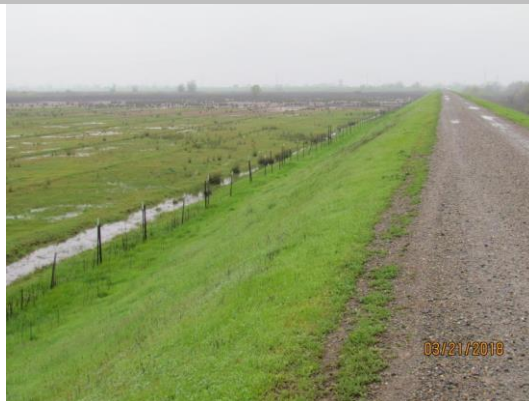
Photo 1 of 1 : SP_2018_RD0784_182_14_20180409_00037.jpg

LM Start	0.02	Rating **	A	Issue No.	14
LM End	4.20	Issue Type +	Ma	Location *	LS
Category	Earthen Levee			GPS Latitude/Longitude	
				Start	End
Item	Vegetation			38.974658 °	39.020572 °
				-121.532691 °	-121.509044 °
DWR ID	DWR_RD0784_05_s_2018_14				
Comment Code					
V1 : Control annual grass and weeds on the levee slopes and easements.					
Inspector Comment					
Annual vegetation is well maintained, Spring 2018.

View looking downstream landside of well maintained annual vegetation, Spring 2018.

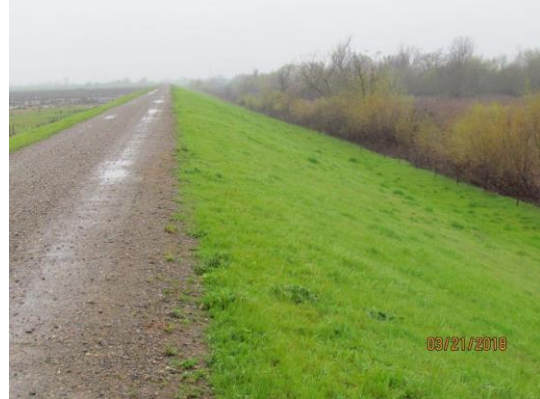
Photo 1 of 1 : SP_2018_RD0784_182_15_20180409_00039.jpg

LM Start	0.02	Rating **	A	Issue No.	15
LM End	4.20	Issue Type +	Ma	Location *	WS
Category	Earthen Levee			GPS Latitude/Longitude	
				Start	End
Item	Vegetation			38.974658 °	39.020572 °
				-121.532691 °	-121.509044 °
DWR ID	DWR_RD0784_05_s_2018_15				
Comment Code					
V1 : Control annual grass and weeds on the levee slopes and easements.					
Inspector Comment					
Annual vegetation is well maintained, Spring 2018.

View looking downstream waterside of well maintained annual vegetation, Spring 2018.

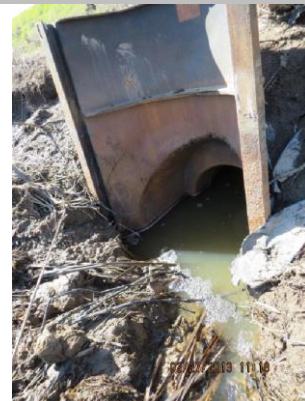
Photo 1 of 3 : UCIP_SP_2018_51711_16552.jpg

LM Start	0.12	Rating **	A/W	Issue No.	17
LM End	0.12	Issue Type +	Ma	Location *	
Category	Supplemental			GPS Latitude/Longitude	
				Start	End
Item	DWR UCIP LMA Responsibility			38.976147 °	38.976147 °
				-121.533019 °	-121.533019 °
DWR ID					
Comment Code					
Inspector Comment					
FS_ID:51711 DS_ID:18592 EP_NO: N/A Repair Type: No Action Needed Crossing Status: Found UCIP Comments: Good candidate for video inspection. FIELD_STRUCT_DESC: 18-inch corrugated metal drainage pipe through the levee, 18 feet below the crown. Flap gate on the waterside (WS) end. Concrete U-shaped headwall on the WS end. Polyvinyl chloride weir inlet on landside (LS) toe. [Additional Reference(s): DWR Levee Log, 2005. USACE Sacramento O&M Manual 145, August 1955 (Station 25+28)]. FS Date: 2/26/2013

inlet control structure on LS toe.

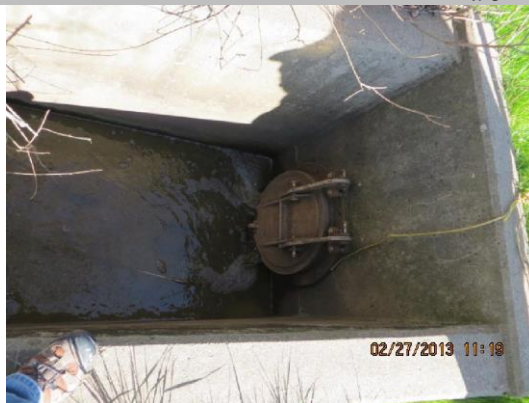
Photo 2 of 3 : UCIP_SP_2018_51711_16555.jpg

Concrete U-shaped outlet with flap gate on WS toe.

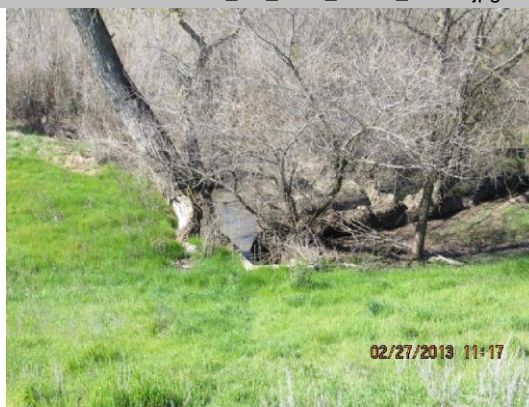
Photo 3 of 3 : UCIP_SP_2018_51711_16554.jpg

Concrete U-shaped outlet on WS toe.

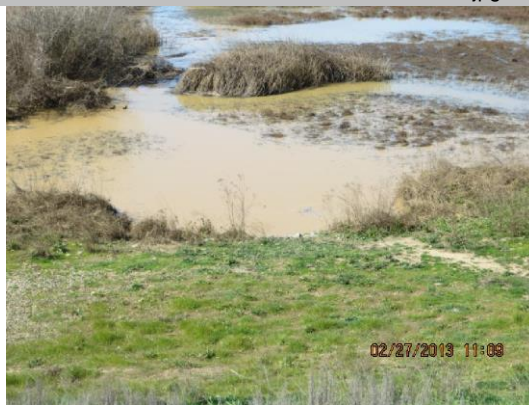
Photo 2 of 2 : UCIP_SP_2018_51710_54245.jpg

Outlet with riprap on WS toe.

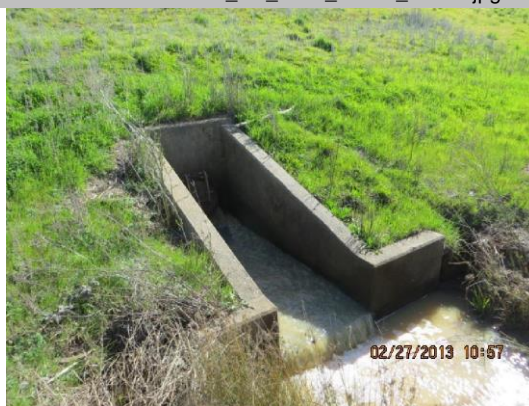
Photo 1 of 3 : UCIP_SP_2018_51709_16565.jpg

LM Start	1.60	Rating **	A/W	Issue No.	19
LM End	1.60	Issue Type +	Ma	Location *	
Category	Supplemental			GPS Latitude/Longitude	
				Start	End
Item	DWR UCIP LMA Responsibility			38.997305 °	38.997305 °
				-121.537081 °	-121.537081 °
DWR ID					
Comment Code					
Inspector Comment					
FS_ID:51709 DS_ID:18590 EP_NO: N/A Repair Type: No Action Needed Crossing Status: Found UCIP Comments: Good candidate for video inspection. FIELD_STRUCT_DESC: 18-inch corrugated metal drainage pipe through the levee, 14.5 feet below the crown. Flap gate on the waterside (WS) end. Concrete U-shaped headwall on the WS. Polyvinyl chloride weir on inlet. (See Drawing No. 2-4-106, Sheet 5). [Additional Reference(s): DWR Levee Log, 2005. USACE Sacramento O&M Manual 145, August 1955 (Station 103+23)]. FS Date: 2/26/2013

Concrete U-shaped headwall and flap gate on WS toe.

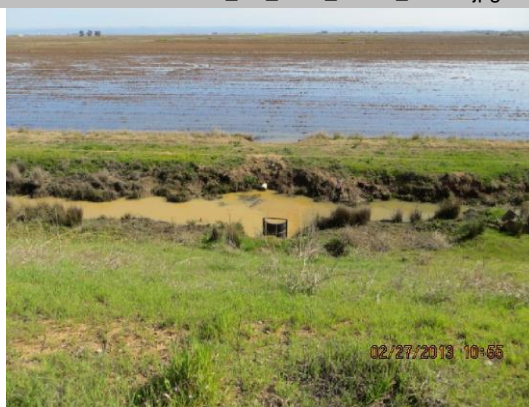
Photo 2 of 3 : UCIP_SP_2018_51709_16563.jpg

Pvc weir on inlet at LS toe.

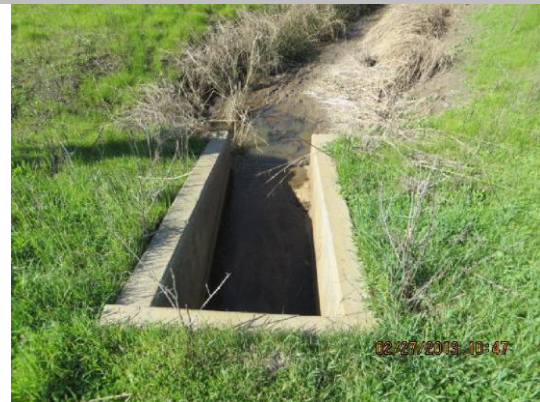
Photo 1 of 3 : UCIP_SP_2018_51719_54247.jpg

LM Start	1.86	Rating **	M	Issue No.	20
LM End	1.86	Issue Type +	Ma	Location *	
Category	Supplemental			GPS Latitude/Longitude	
				Start	End
Item	DWR UCIP LMA Responsibility			39.000975 °	39.000975 °
				-121.537779 °	-121.537779 °
DWR ID					
Comment Code					
Inspector Comment					
FS_ID:51719 DS_ID:18588 EP_NO: N/A Repair Type: Non-Urgent Crossing Status: Found UCIP Comments: 09/11/2015 Inlet burried. Good candidate for video inspection as pipe is corroded. (G. Wylie - FPIIB) FIELD_STRUCT_DESC: 18-inch corrugated metal drainage pipe through the levee, 14.5 feet below the crown. Flap gate on the waterside (WS) end. Concrete U-shaped headwall on the WS. [Additional Reference(s): DWR Levee Log, 2005. USACE Sacramento O&M Manual 145, August 1955 (Station 116+78)]. FS Date: 9/11/2015 9:36:00 AM

Concrete U-shaped outlet and flap-gate on WS toe.

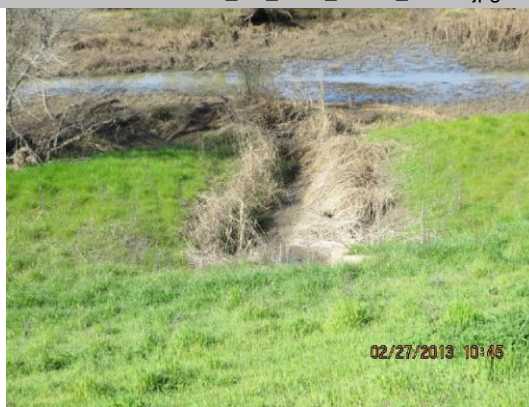
Photo 3 of 3 : UCIP_SP_2018_51719_54249.jpg

Drainage outlet on WS toe.

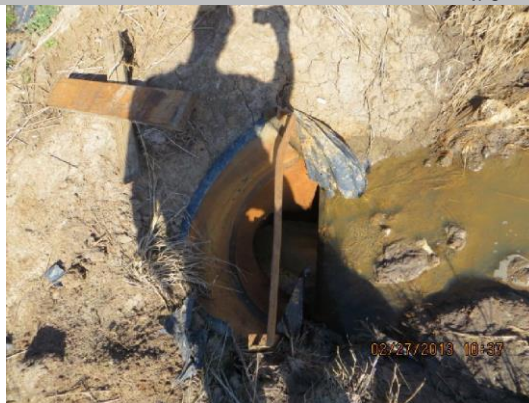
Photo 1 of 3 : UCIP_SP_2018_51707_54250.jpg

Inlet with PVC weir on LS toe.

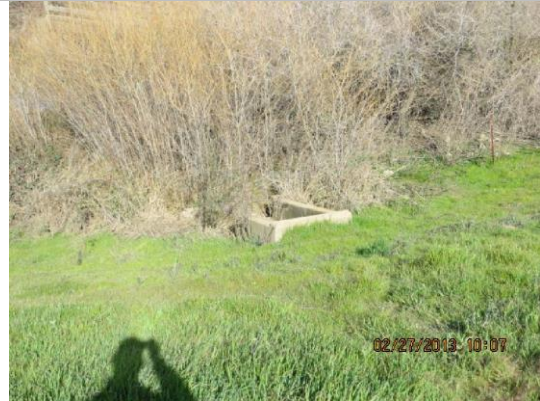
Photo 3 of 3 : UCIP_SP_2018_51714_54261.jpg

Comment Code						
Inspector Comment						
FS_ID:51714 DS_ID:18596 EP_NO: N/A Repair Type: Non-Urgent Crossing Status: Found UCIP Comments: Pipe has been sliplined with PVC, but the liner appears to be eroding at outlet and may be disjointed internal to the levee. See pic. Good candidate for video inspection. FIELD_STRUCT_DESC: 12-inch corrugated metal drainage pipe through the levee, 12 feet below the crown. Flap gate and concrete U-shaped headwall on the waterside (WS). Polyvinyl chloride weir on inlet at the landside (LS) toe. [Additional Reference(s): DWR Levee Log, 2005. USACE Sacramento O&M Manual 145, August 1955 (Station 44+96)]. FS Date: 9/11/2015 9:26:00 AM

Concrete U-shaped headwall on WS toe.

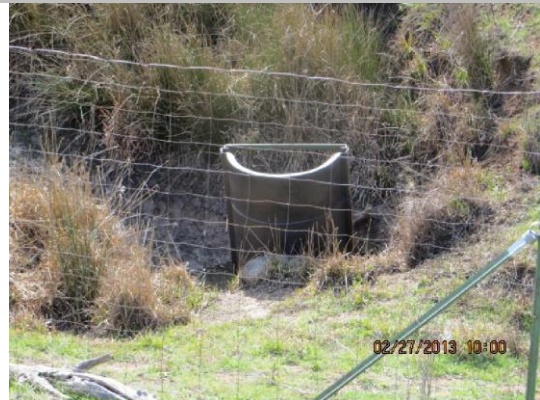
Photo 1 of 2 : UCIP_SP_2018_9566_16594.jpg

LM Start	3.23	Rating **	A/W	Issue No.	24
LM End	3.23	Issue Type +	Ma	Location *	
Category	Supplemental			GPS Latitude/Longitude	
				Start	End
Item	DWR UCIP LMA Responsibility			39.017336 °	39.017336 °
				-121.526530 °	-121.526530 °
DWR ID					
Comment Code					
Inspector Comment					
FS_ID:9566 DS_ID:18595 EP_NO: N/A Repair Type: No Action Needed Crossing Status: Found UCIP Comments: Good candidate for video inspection. FIELD_STRUCT_DESC: 18-inch corrugated metal drainage pipe through the levee, 15.8 feet below the crown. Flap gate on the waterside (WS) end. Polyvinyl chloride weir on inlet at the landside (LS) toe. [Additional Reference(s): DWR Levee Log, 2005. USACE Sacramento O&M Manual 145, August 1955, Drawing No. 2-4-106, Sheet 6 (Station 53+86)]. FS Date: 2/27/2013

PVC weir inlet on LS toe.

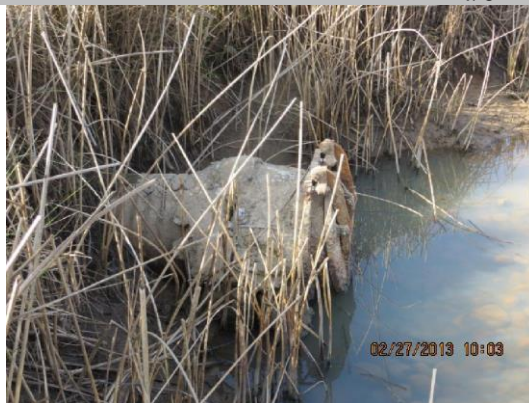
Photo 2 of 2 : UCIP_SP_2018_9566_16593.jpg

LM Start	3.23	Rating **	A/W	Issue No.	24 (cont)	
LM End	3.23	Issue Type +	Ma	Location *		
Category	Supplemental			GPS Latitude/Longitude		
				Start		End
Item	DWR UCIP LMA Responsibility			39.017336 °		39.017336 °
				-121.526530 °		-121.526530 °
DWR ID						
Comment Code						
Inspector Comment						
FS_ID:9566 DS_ID:18595 EP_NO: N/A Repair Type: No Action Needed Crossing Status: Found UCIP Comments: Good candidate for video inspection. FIELD_STRUCT_DESC: 18-inch corrugated metal drainage pipe through the levee, 15.8 feet below the crown. Flap gate on the waterside (WS) end. Polyvinyl chloride weir on inlet at the landside (LS) toe. [Additional Reference(s): DWR Levee Log, 2005. USACE Sacramento O&M Manual 145, August 1955, Drawing No. 2-4-106, Sheet 6 (Station 53+86)]. FS Date: 2/27/2013

Flap gate at WS toe.

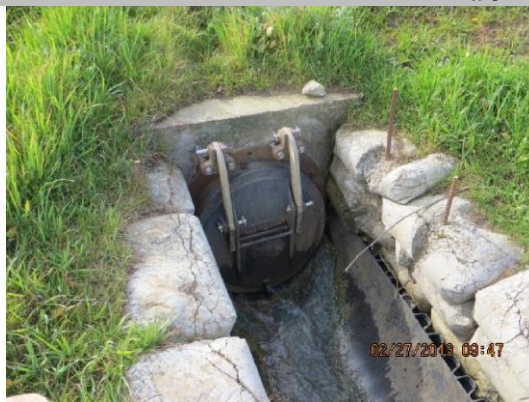
Photo 1 of 3 : UCIP_SP_2018_51713_16590.jpg

LM Start	3.79	Rating **	A/W	Issue No.	25
LM End	3.79	Issue Type +	Ma	Location *	
Category	Supplemental			GPS Latitude/Longitude	
				Start	End
Item	DWR UCIP LMA Responsibility			39.019222 °	39.019222 °
				-121.516414 °	-121.516414 °
DWR ID					
Comment Code					
Inspector Comment					
FS_ID:51713 DS_ID:18594 EP_NO: N/A Repair Type: No Action Needed Crossing Status: Found UCIP Comments: FIELD_STRUCT_DESC: 18-inch corrugated metal drainage pipe through the levee, 8.8 feet below the crown. Flap gate and headwall on the waterside (WS) end. [Additional Reference(s): DWR Levee Log, 2005. USACE Sacramento O&M Manual 145, August 1955 (Station 83+39)]. FS Date: 2/27/2013

Concrete outlet and flap gate on WS toe.

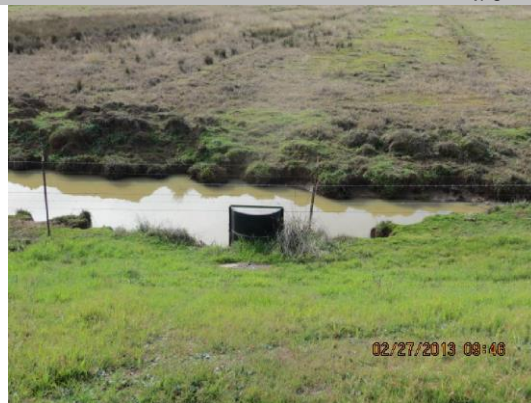
Photo 2 of 3 : UCIP_SP_2018_51713_16591.jpg

LM Start	3.79	Rating **	A/W	Issue No.	25 (cont)	
LM End	3.79	Issue Type +	Ma	Location *		
Category	Supplemental			GPS Latitude/Longitude		
				Start	End	
Item	DWR UCIP LMA Responsibility			39.019222 °	39.019222 °	
				-121.516414 °	-121.516414 °	
DWR ID						
Comment Code						
Inspector Comment						
FS_ID:51713						
DS_ID:18594						
EP_NO: N/A						
Repair Type: No Action Needed						
Crossing Status: Found						
UCIP Comments:						
FIELD_STRUCT_DESC: 18-inch corrugated metal drainage pipe through the levee, 8.8 feet below the crown. Flap gate and headwall on the waterside (WS) end. [Additional Reference(s): DWR Levee Log, 2005. USACE Sacramento O&M Manual 145, August 1955 (Station 83+39)].						
FS Date: 2/27/2013

PVC weir at inlet on LS toe.

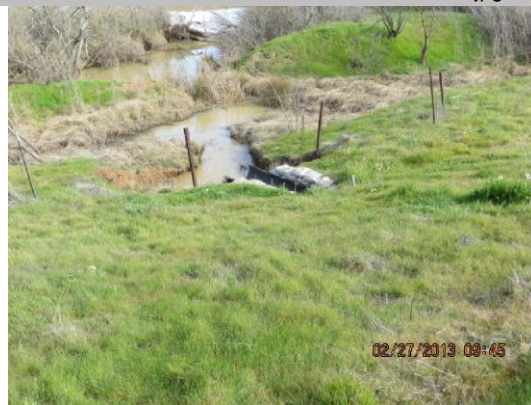
Photo 3 of 3 : UCIP_SP_2018_51713_16592.jpg

Concrete outlet on WS toe.

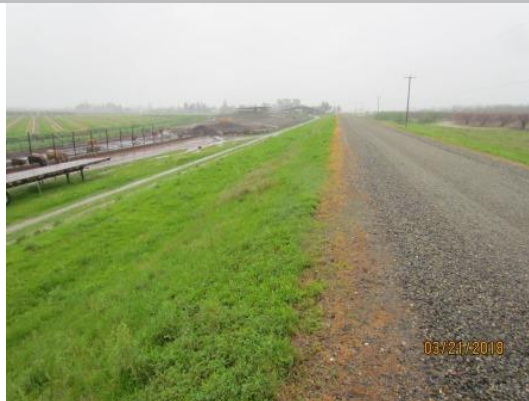
Photo 1 of 1 : SP_2018_RD0784_183_2_20180409_00005.jpg

LM Start	0.00	Rating **	A	Issue No.	2
LM End	0.25	Issue Type +	Ma	Location *	LS
Category	Earthen Levee			GPS Latitude/Longitude	
				Start	End
Item	Vegetation			38.985544 °	38.987580 °
				-121.510536 °	-121.506663 °
DWR ID	DWR_RD0784_06_s_2018_2				
Comment Code					
V1 : Control annual grass and weeds on the levee slopes and easements.					
Inspector Comment					
Annual vegetation is well maintained, Spring 2018.

View looking upstream landside of the well maintained annual vegetation, Spring 2018.

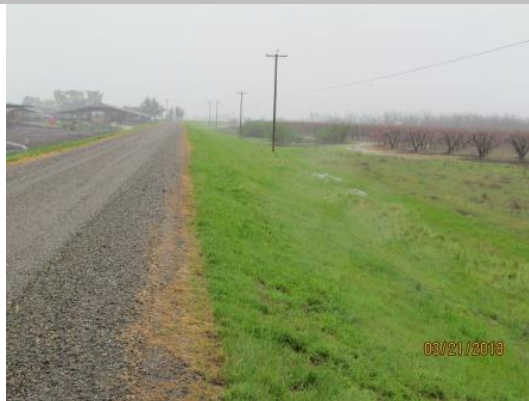
Photo 1 of 1 : SP_2018_RD0784_183_3_20180409_00004.jpg

LM Start	0.00	Rating **	A	Issue No.	3
LM End	0.25	Issue Type +	Ma	Location *	WS
Category	Earthen Levee			GPS Latitude/Longitude	
				Start	End
Item	Vegetation			38.985544 °	38.987580 °
				-121.510536 °	-121.506663 °
DWR ID	DWR_RD0784_06_s_2018_3				
Comment Code					
V1 : Control annual grass and weeds on the levee slopes and easements.					
Inspector Comment					
Annual vegetation is well maintained, Spring 2018.

View looking upstream waterside of the well maintained annual vegetation, Spring 2018.

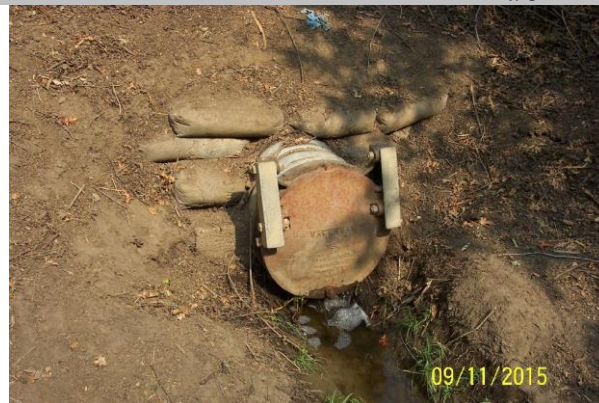
Photo 1 of 3 : UCIP_SP_2018_51716_74682.jpg

LM Start	0.06	Rating **	M	Issue No.	4
LM End	0.06	Issue Type +	Ma	Location *	
Category	Supplemental			GPS Latitude/Longitude	
				Start	End
Item	DWR UCIP LMA Responsibility			38.985999 °	38.985999 °
				-121.509618 °	-121.509618 °
DWR ID					
Comment Code					
Inspector Comment					
FS_ID:51716 DS_ID:18626 EP_NO: N/A Repair Type: Non-Urgent Crossing Status: Found UCIP Comments: 10-30-2015 - Waterside flap gate was cleared in December 2014 and again in September 2015 No LMA access available on Landside (P. Meagher).Pipe partially blocked on LS and flap gate blocked on WS (W. Wylie-UCIP Inspector) FIELD_STRUCT_DESC: 18-inch corrugated metal storm drainage pipe through the levee, 19 feet below the crown. Gate valve on the waterside (WS). [Additional Reference(s): USACE Drawing No. 2-4-106, Sheet 2]. FS Date: 9/11/2015

Flap Gate is clear as of 9/11/15.

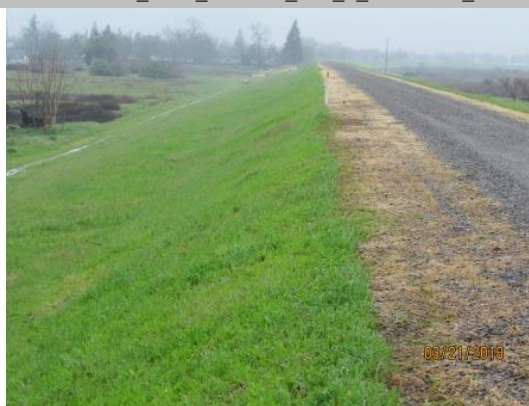
Photo 1 of 1 : SP_2018_RD0784_184_1_20180409_00002.jpg

LM Start	0.00	Rating **	A	Issue No.	1
LM End	3.81	Issue Type +	Ma	Location *	LS
Category	Earthen Levee			GPS Latitude/Longitude	
				Start	End
Item	Vegetation			39.134846 °	39.165499 °
				-121.552209 °	-121.495600 °
DWR ID	DWR_RD0784_07_s_2018_1				
Comment Code					
V1 : Control annual grass and weeds on the levee slopes and easements.					
Inspector Comment					
Annual vegetation is well maintained, Spring 2018.

View looking downstream landside of the well maintained annual vegetation, Spring 2018.

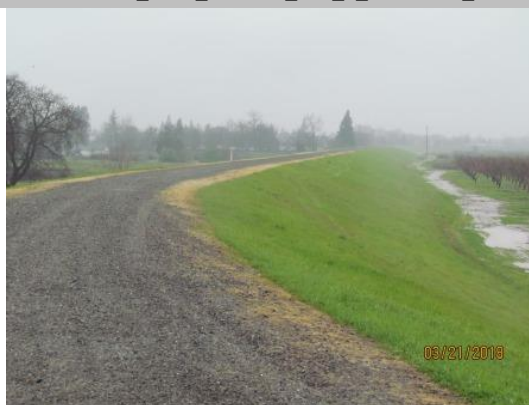
Photo 1 of 1 : SP_2018_RD0784_184_2_20180409_00004.jpg

LM Start	0.00	Rating **	A	Issue No.	2
LM End	3.81	Issue Type +	Ma	Location *	WS
Category	Earthen Levee			GPS Latitude/Longitude	
				Start	End
Item	Vegetation			39.134846 °	39.165500 °
				-121.552209 °	-121.495600 °
DWR ID	DWR_RD0784_07_s_2018_2				
Comment Code					
V1 : Control annual grass and weeds on the levee slopes and easements.					
Inspector Comment					
Annual vegetation is well maintained, Spring 2018.

View looking downstream waterside of the well maintained annual vegetation, Spring 2018.

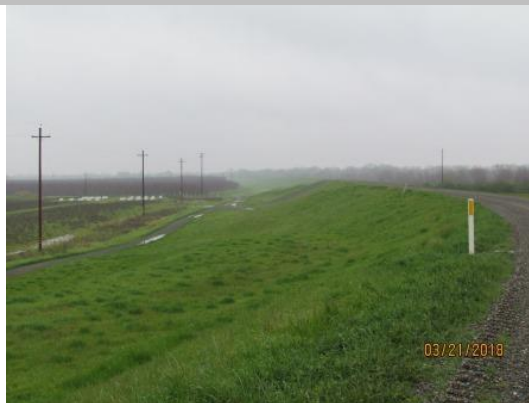
Photo 1 of 1 : SP_2018_RD0784_437_1_20180409_00002.jpg

LM Start	0.02	Rating **	A	Issue No.	1
LM End	1.93	Issue Type +	Ma	Location *	LS
Category	Earthen Levee			GPS Latitude/Longitude	
				Start	End
Item	Vegetation			38.955531 °	38.970554 °
				-121.574502 °	-121.547593 °
DWR ID	DWR_RD0784_08_s_2018_1				
Comment Code					
V1 : Control annual grass and weeds on the levee slopes and easements.					
Inspector Comment					
Annual vegetation is well maintained, Spring 2018.

View looking upstream landside of the well maintained annual vegetation, Spring 2018.

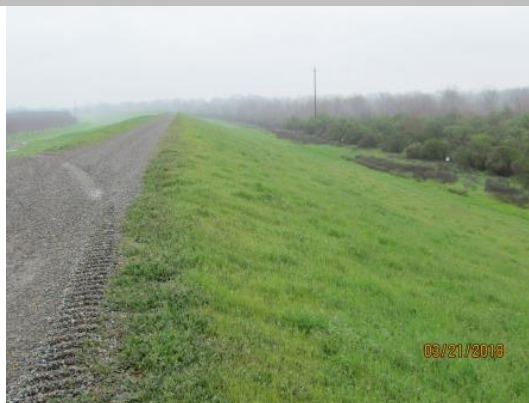
Photo 1 of 1 : SP_2018_RD0784_437_2_20180409_00001.jpg

LM Start	0.02	Rating **	A	Issue No.	2
LM End	1.93	Issue Type +	Ma	Location *	WS
Category	Earthen Levee			GPS Latitude/Longitude	
				Start	End
Item	Vegetation			38.955531 °	38.970556 °
				-121.574502 °	-121.547592 °
DWR ID	DWR_RD0784_08_s_2018_2				
Comment Code					
V1 : Control annual grass and weeds on the levee slopes and easements.					
Inspector Comment					
Annual vegetation is well maintained, Spring 2018.

View looking upstream waterside of the well maintained annual vegetation, Spring 2018.

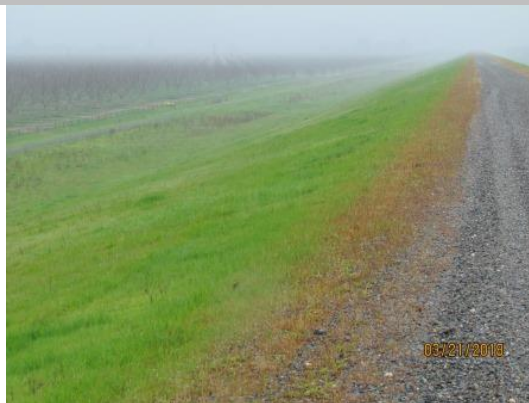
Photo 1 of 1 : SP_2018_RD0784_530_1_20180409_00001.jpg

LM Start	0.01	Rating **	A	Issue No.	1
LM End	5.73	Issue Type +	Ma	Location *	WS
Category	Earthen Levee			GPS Latitude/Longitude	
				Start	End
Item	Vegetation			39.090160 °	39.009878 °
				-121.584749 °	-121.579154 °
DWR ID	DWR_RD0784_09_s_2018_1				
Comment Code					
V1 : Control annual grass and weeds on the levee slopes and easements.					
Inspector Comment					
Annual vegetation is well maintained, Spring 2018.

View looking downstream landside of the well maintained annual vegetation, Spring 2018.

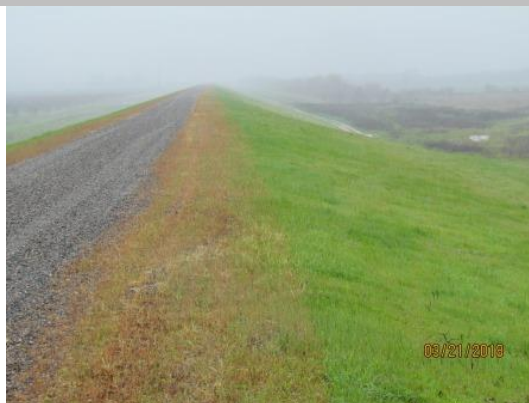
Photo 1 of 1 : SP_2018_RD0784_530_2_20180409_00002.jpg

LM Start	0.01	Rating **	A	Issue No.	2
LM End	5.73	Issue Type +	Ma	Location *	WS
Category	Earthen Levee			GPS Latitude/Longitude	
				Start	End
Item	Vegetation			39.090160 °	39.009879 °
				-121.584750 °	-121.579154 °
DWR ID	DWR_RD0784_09_s_2018_2				
Comment Code					
V1 : Control annual grass and weeds on the levee slopes and easements.					
Inspector Comment					
Annual vegetation is well maintained, Spring 2018.

View looking downstream waterside of the well maintained annual vegetation, Spring 2018.
